SPOONWOOD POND DAM

NH 00338

**PHASE I INSPECTION REPORT
NATIONAL DAM INSPECTION PROGRAM**

Inventory No.: NH 00338
NHWRB No.: 116.03
Name of Dam: SPOONWOOD POND
Town: Nelson
County and State: Cheshire County, New Hampshire
Stream: Nubanusit Brook, Tributary to Contoocook River
Date of Inspection: 18 July 1978

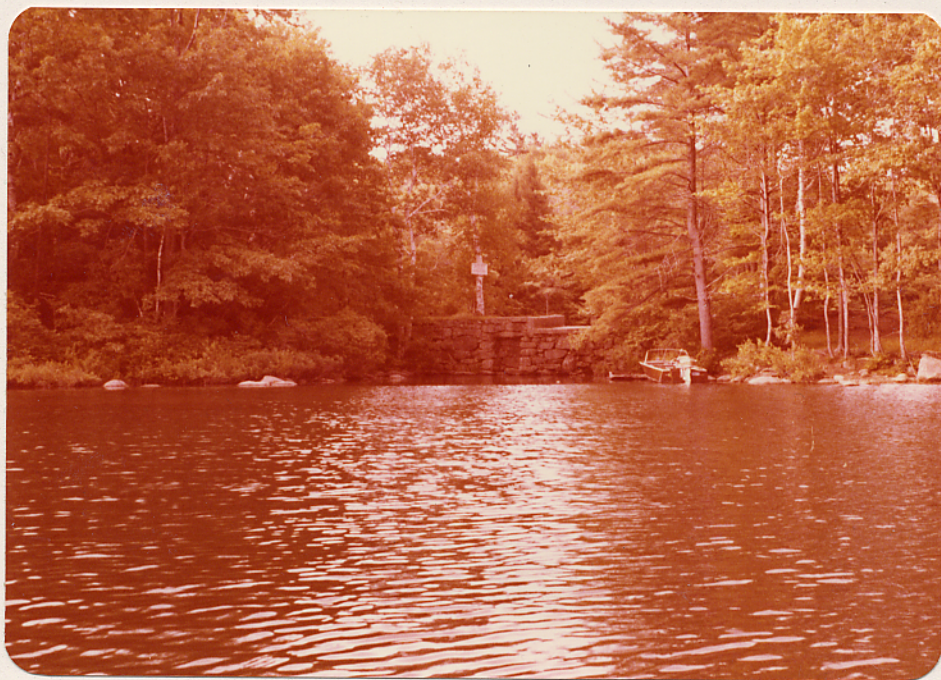
Overview of dam from downstream

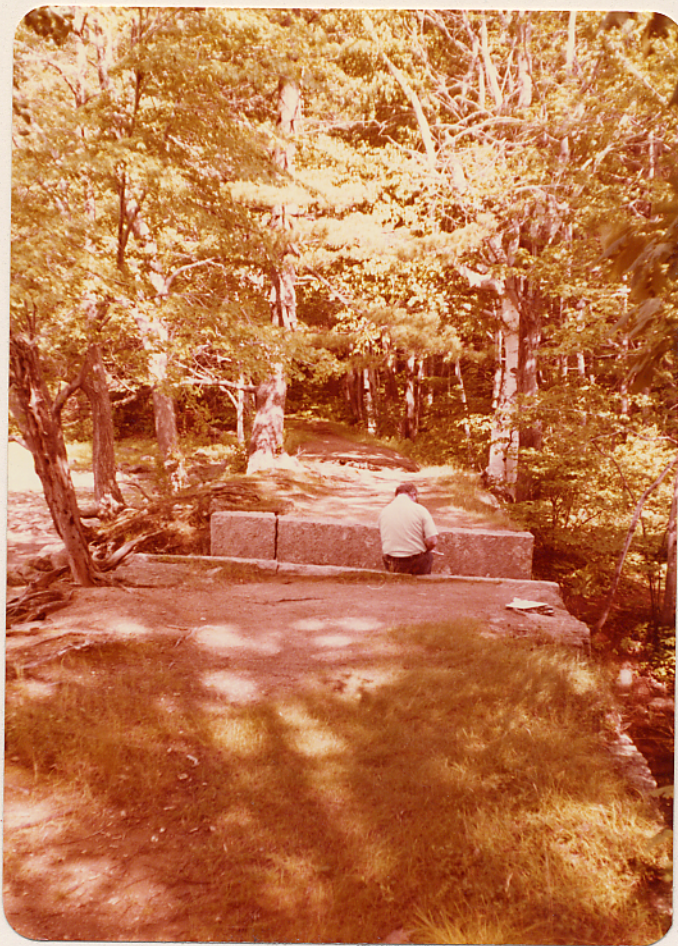
Overview of left abutment from spillway area

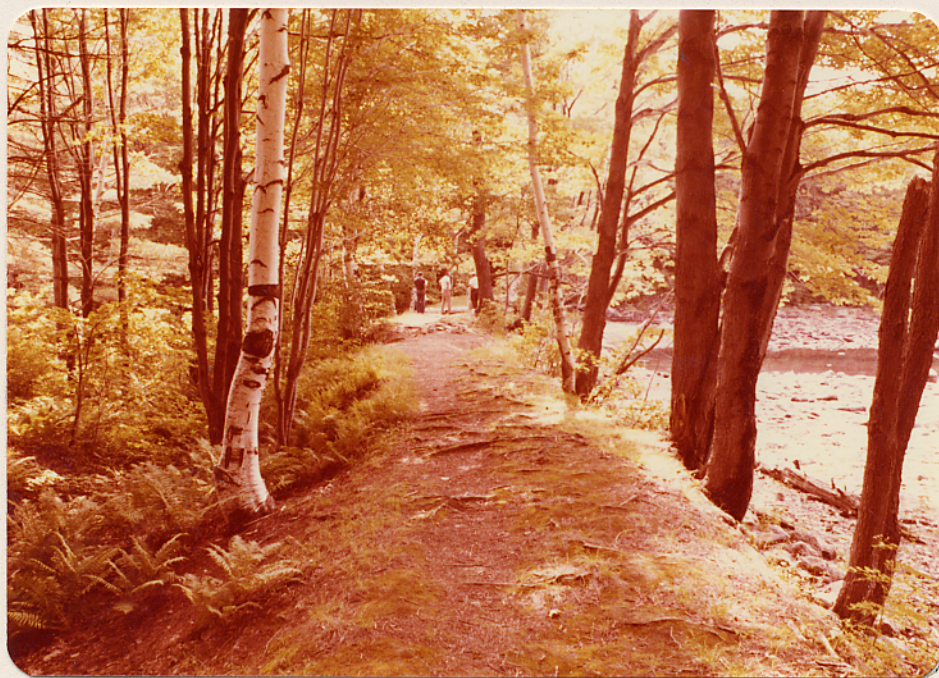
Overview from left abutment

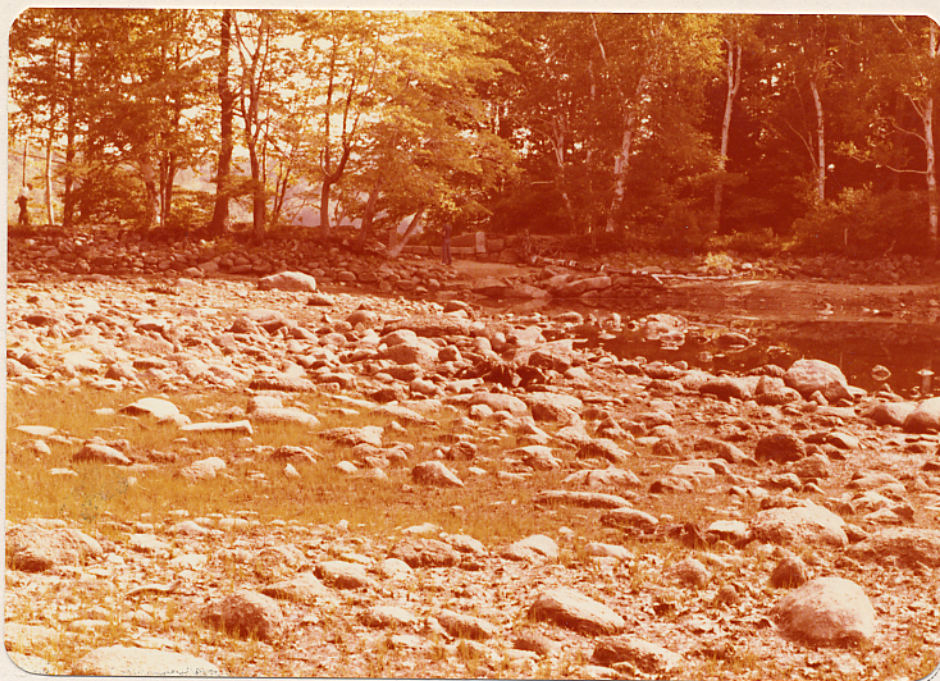
The two embankment sections which flank the spillway show no evidence of vertical or horizontal movement. The drawn down condition of the pond precluded any observation of seepage which might occur under head. Both embankments had a significant number of large, mature trees growing along their entire length. There is evidence of erosion all along the dam, particularly in the areas of the portages. Riprap protection was random and generally inadequate.

View from upstream showing pond bottom and upstream slope protection

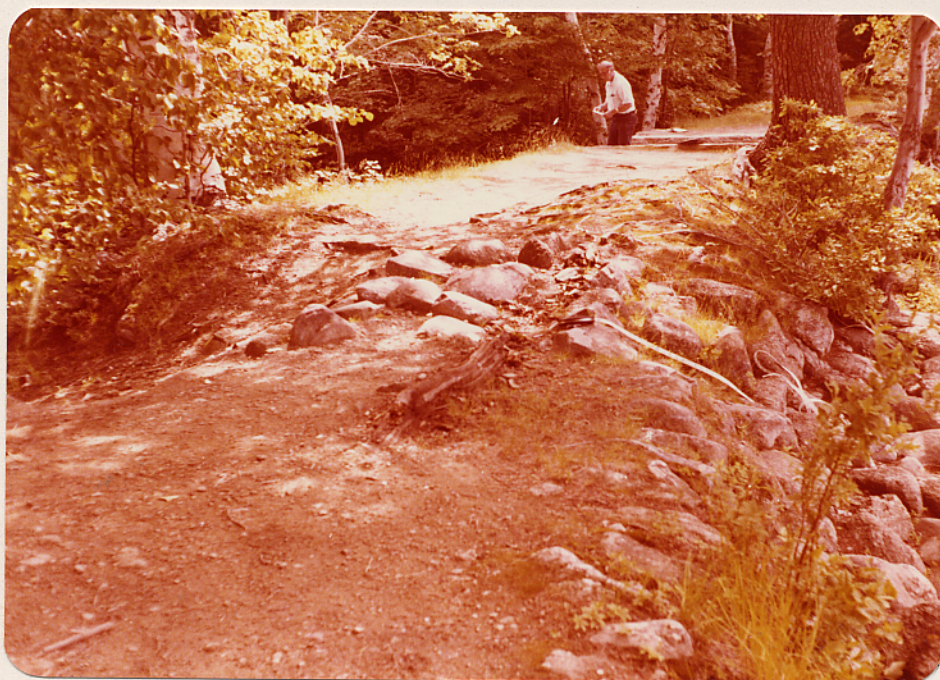
The owner visits the dam several times during the year and notes any required maintenance. The repair of a portage over the dam by which sportsmen haul boats is an area receiving regular attention, generally additional fill and riprap. While significant problems seem to be expeditiously handled, numerous trees are growing on the dam, there are several eroded areas and the spillway is deteriorating.

2. View from left abutment showing portage near spillway

- (4) Repair all eroded areas on both embankments, particularly behind the spillway and at the portages and place additional riprap where required to insure future protection.

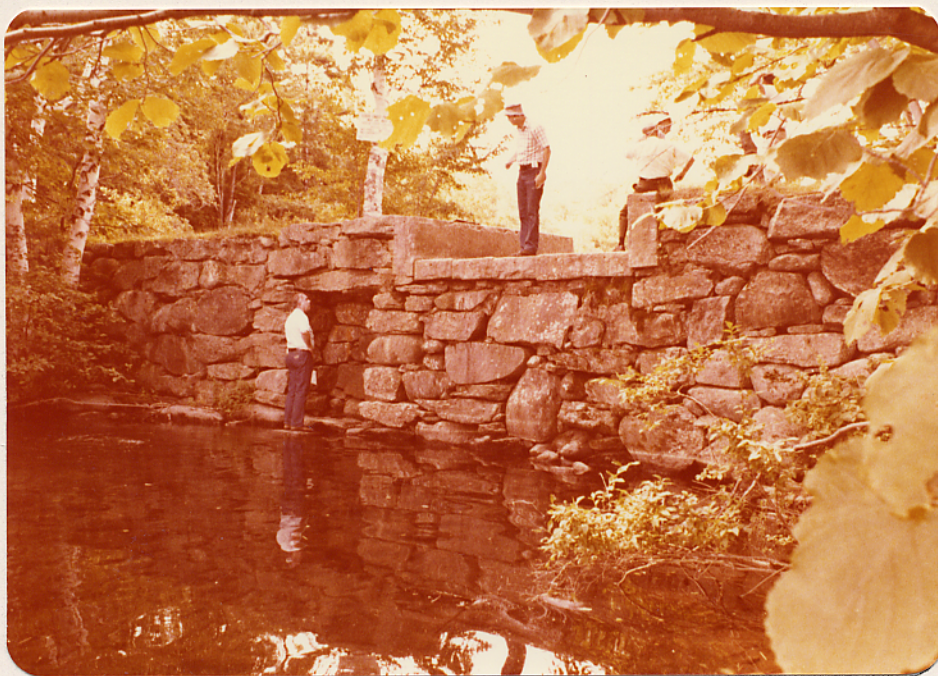
The dam's normal impoundment of 500 acre-feet and 12 foot height places it in the SMALL category as defined in the "Recommended Guidelines." The pond is essentially on a plateau and is rather shallow; the downstream height of the dam is somewhat deceptive (Photo 3).

Both ends of the pipe were under water despite the drawn down condition of the pond. Massive boulders with large interstices cover the upstream end and serve as a crude, but effective, screen for debris. The gate valve in the pipe is not operative due to a broken turning nut on its stem.

3. View of spillway and area containing gate valve downstream left side

- (1) Repair the gate valve.
- (2) Remove uprooted trees and reshape and riprap the former root zones.
- (3) In accordance with the recommendations of the study mentioned above, remove all trees and other vegetation from the embankment.

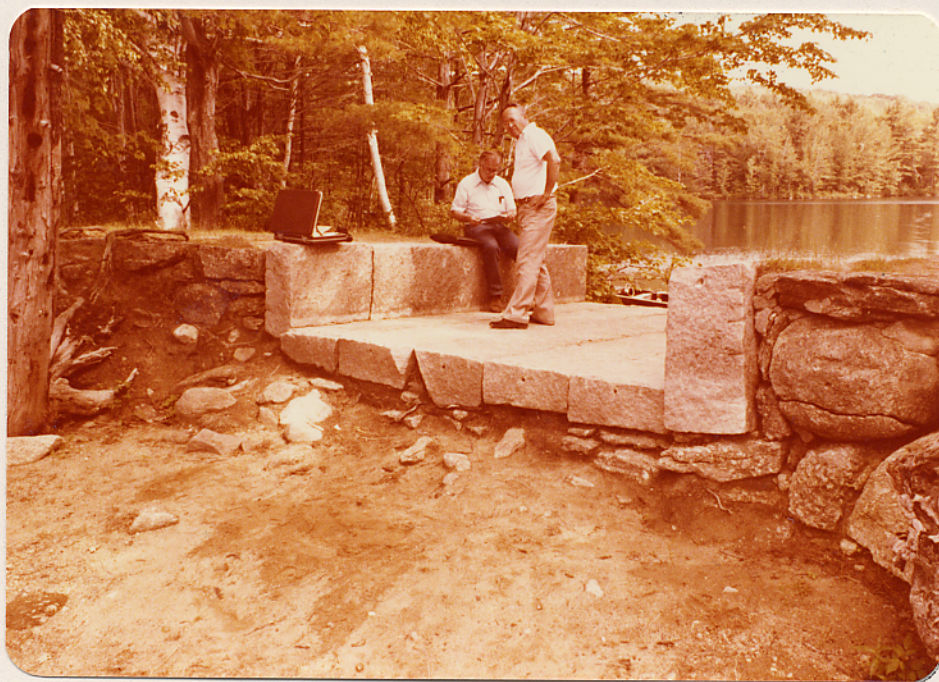
The granite slabs which form the spillway are in good condition, although some of the previously leaded joints are now open. The upstream end of the spillway has lost some of its support owing to erosion of the underlying soil. The dry rubble stone masonry under the downstream end of the spillway contains many voids, some as deep as 6 feet. The owner indicates that no seepage occurs through these voids, even under full pond.

4. Detail of spillway construction from upstream right side

- (5) Seal all joints between the granite spillway slabs.
- (6) Watch for potential leaks through the extensive voids in the dry rubble stone masonry.
- (7) Institute formal periodic inspections on at least an annual basis. Since the site is accessible only by boat, the owner should provide continual surveillance in the area during periods of unusually heavy precipitation.
